# Safety Inspection Report

Annual Inspection

## Coates Village Green

Coates Parish Council

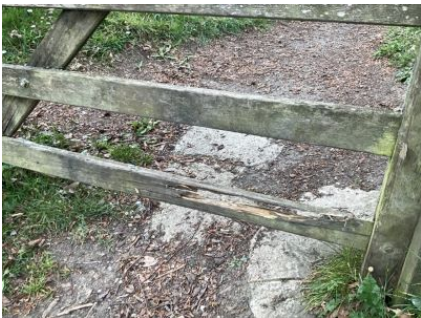
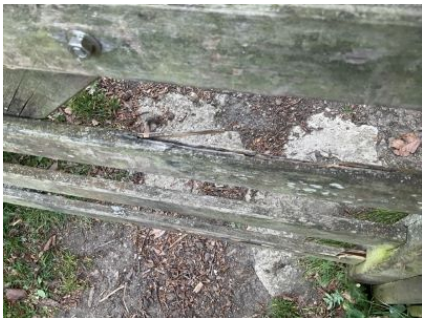
There is a crushing or shearing point on the side of the gate. Where the gaps reduce to less than 12 mm these have been known to cause serious, permanent injury to children, especially on the hinge side where the leverage forces are significant.

Adjust gate / posts / fit new rubber buffer to ensure a spacing of at least 12 mm throughout the range of the gate to remove the entrapment. The 12 mm gap also should apply on the hinge side of the gate.

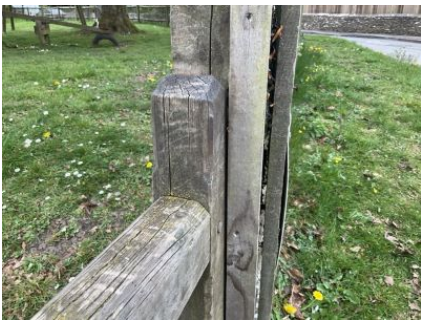
Fixtures loose or missing.

Replace.

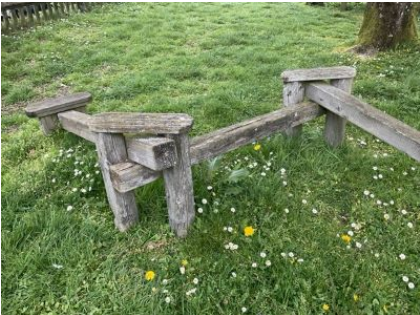
Timber is decayed.

Two middle sections decayed in the ground. Replace.

Read the notes for further action.

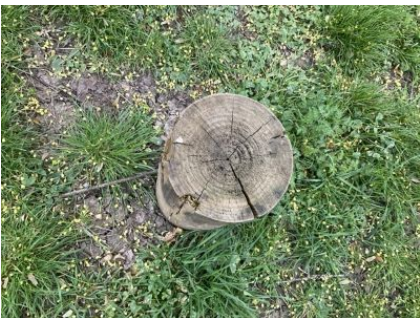
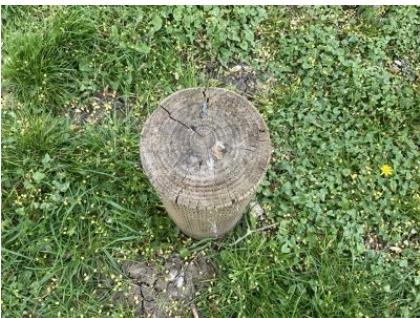
There are splinters or the potential for splinters.

Sand the timber down to remove the splinters and/or the places liable to give splinters.

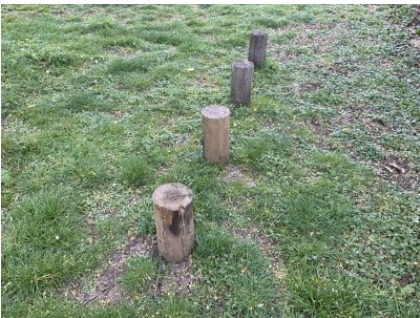
Loose in ground.

Reset.

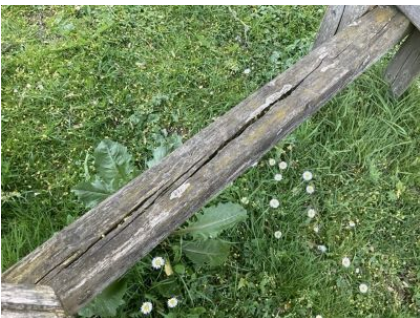
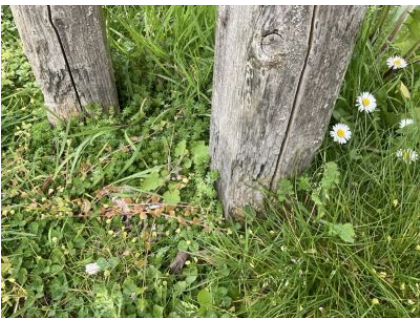
Timber is decayed.

Middle balance beam is decaying within shakes. Posts softening at ground level.

Replace affected parts.

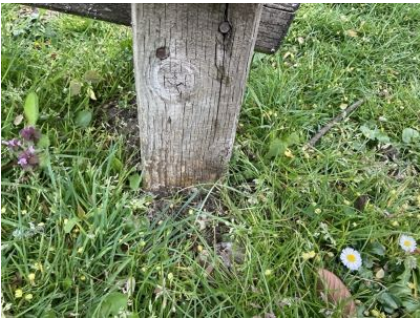
Strimmer damage is present on posts, allowing water to enter and timbers to soften. It can also remove the protective envelope around the timber. Prevent further damage and check timbers for decay throughout the year.

Prevent further damage.

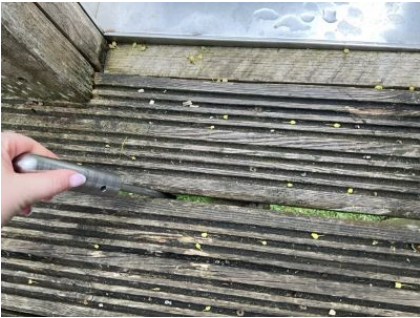
Finger entrapment.

Gaps exceeding 8 mm near exits/openings on platform with fireman’s pole and climbing wall.

Eliminate the entrapment.

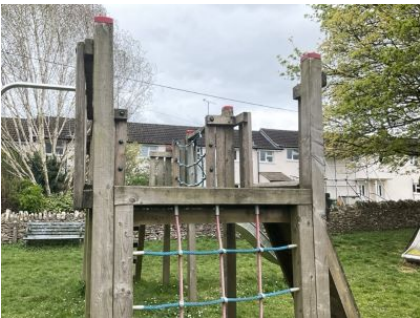
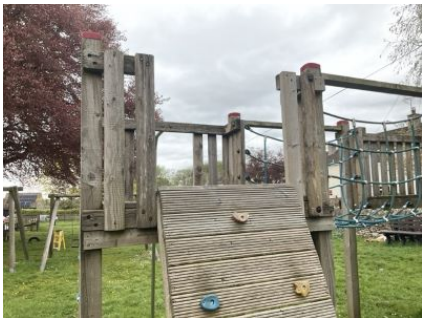
The openings for the steep play element are greater than 1200 m wide, or they do not have a protective guard rail.

No reasonably practicable action is identified.

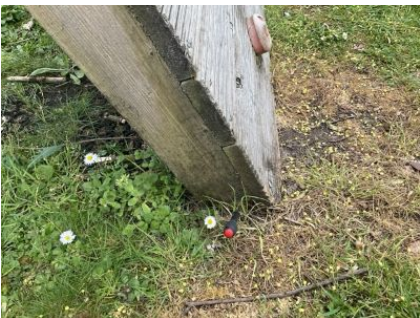
Timber is decayed.

Climbing wall posts.

Replace affected parts.

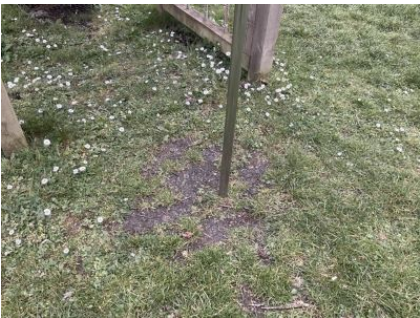
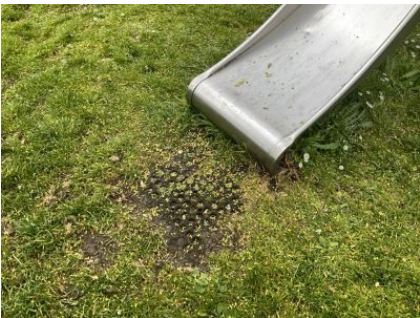
Surface is wearing.

Monitor for significant deterioration and rectify when necessary.

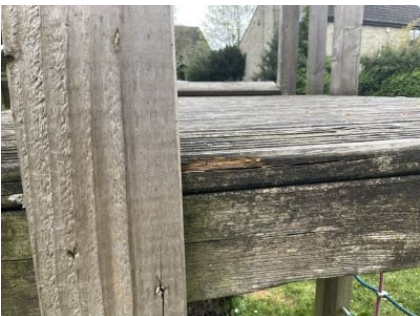
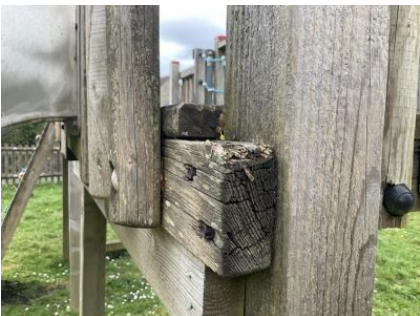
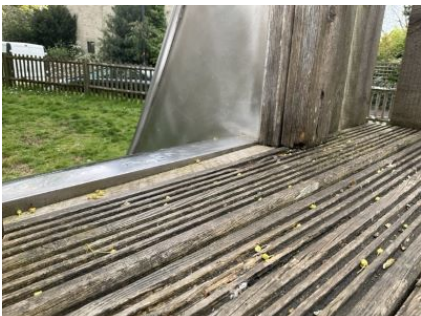
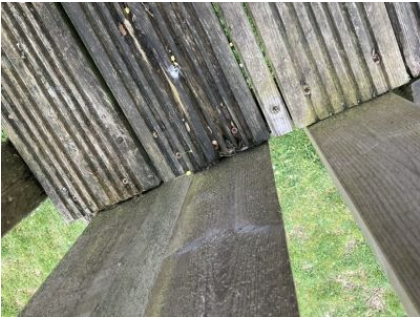
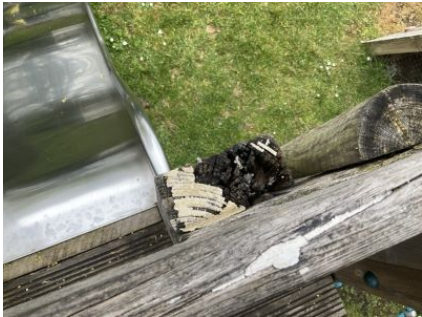
Timber is decayed.

Some beams decaying. Replace/reinforce.  
Monitor for further significant decay.

Check on a routine basis., Repair.

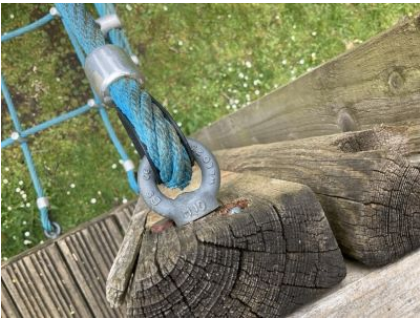
Bolt(s) loose.

Tighten.

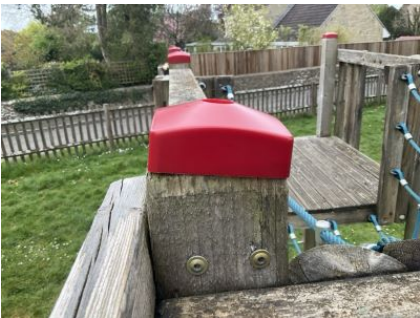
Fixtures loose or missing.

Tighten.

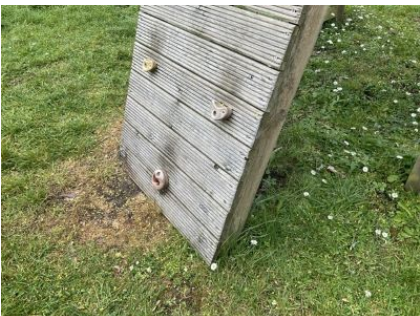
Item is not secure.

Climbing wall is not secured to surface. Monitor and consider alterations if becomes loose.

Read the notes for further action.

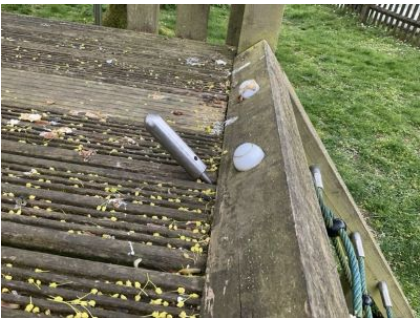
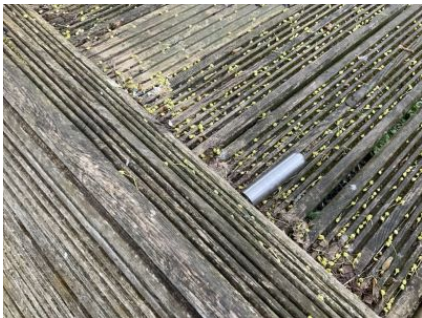
Finger entrapment.

Eliminate the entrapment.

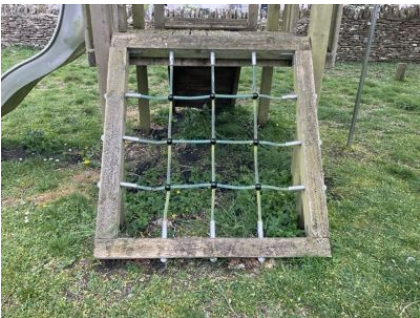
The supports are within the falling or free space area.

No reasonably practicable action is identified.

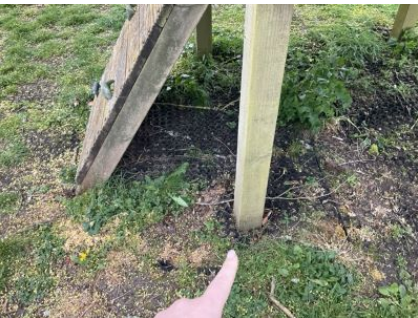
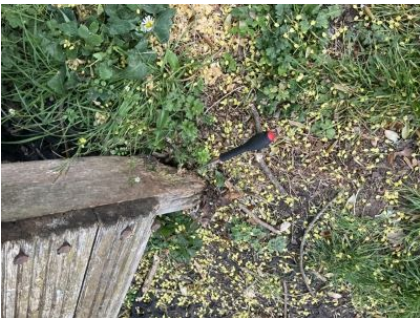
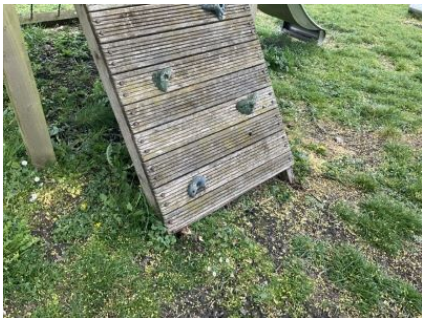
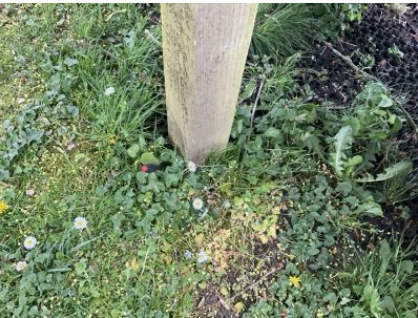
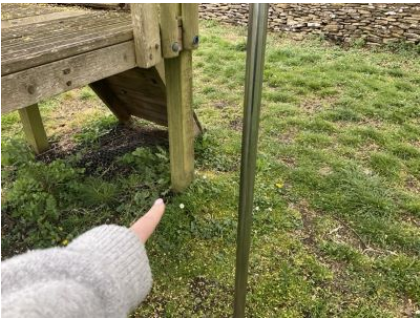
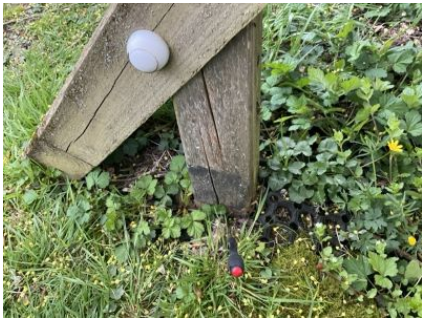
Timber is decayed.

Replace affected parts.

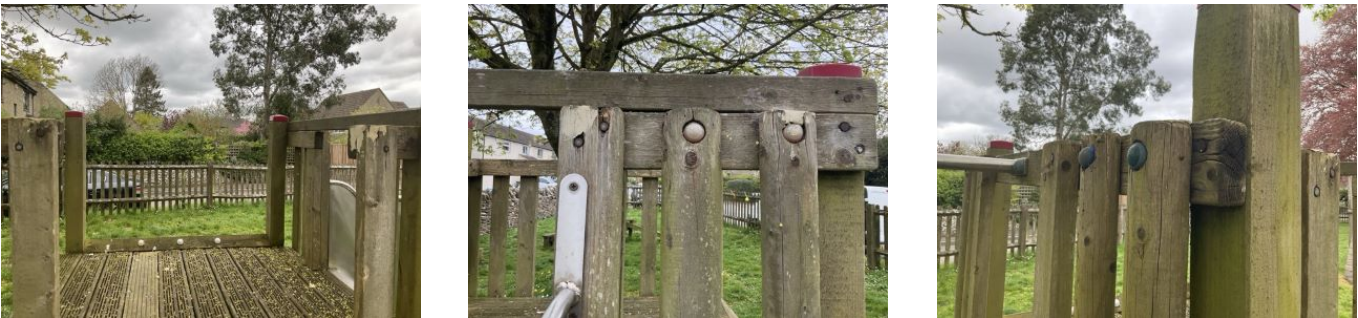
Timber is decayed.

Check on a routine basis.

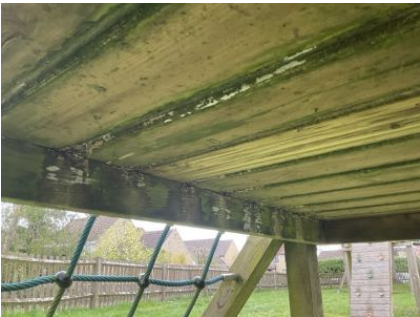
Timber is decayed.

White fungus growth on underside of platform. Clean off and treat timber.  
Monitor for significant decay.

Check on a routine basis., Repair.

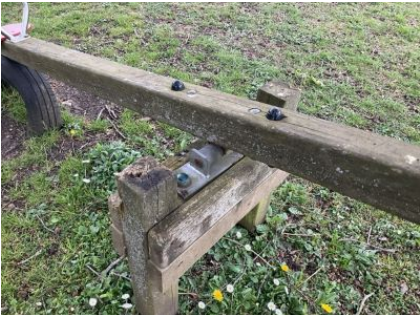
There is evident wear to the internal mechanism, resulting in excessive sideways movement.

Bolts are loose.

Repair.

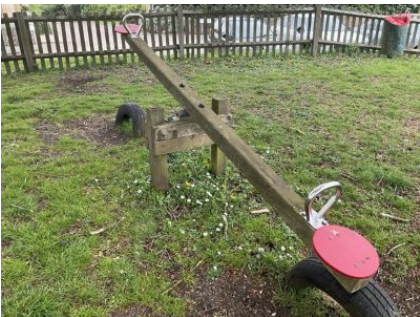
Loose in ground.

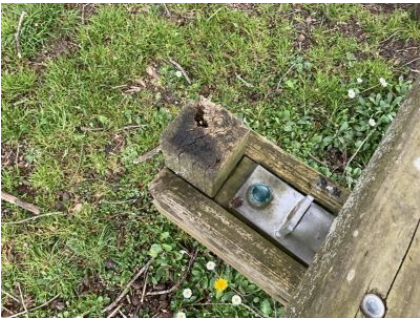
Timber is decayed.

Minor decay on top of support post.  
Cut down to good wood, chamfer edges and treat timber.  
Monitor timber softening at ground level.

Repair.

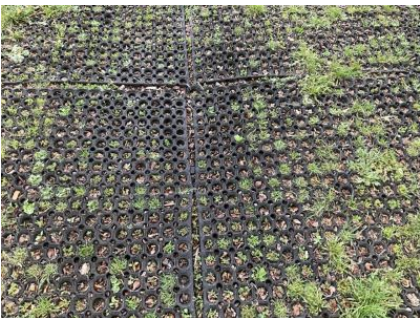
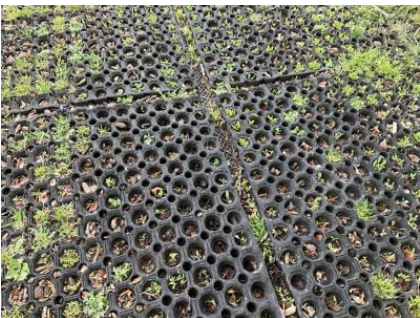
Surface needs repair.

Repair.

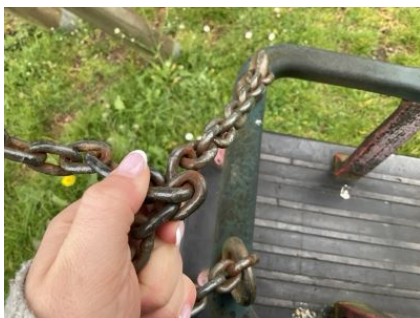
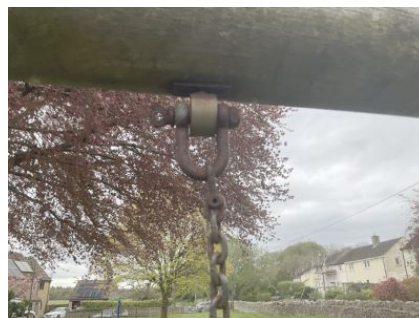
Some chain wear.

Monitor for further deterioration and replace before 40% wear.

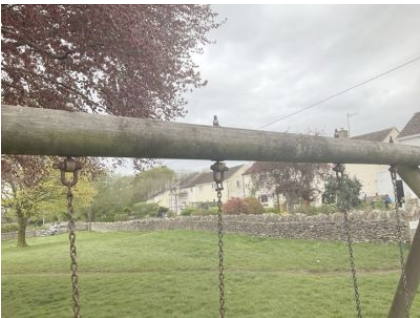
Cap missing.

Replace.
