# Safety Inspection Report

Annual Inspection

## Coates Village Green

Coates Parish Council

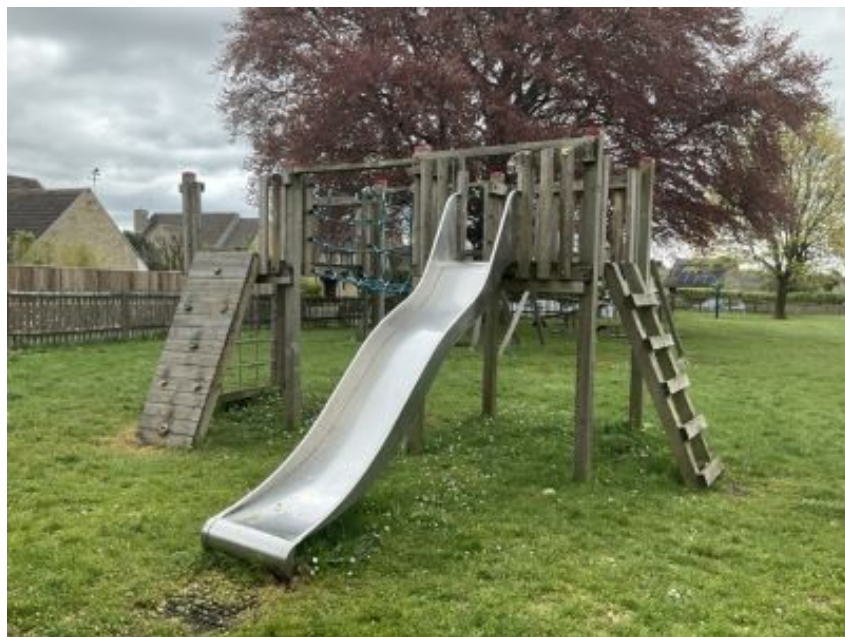
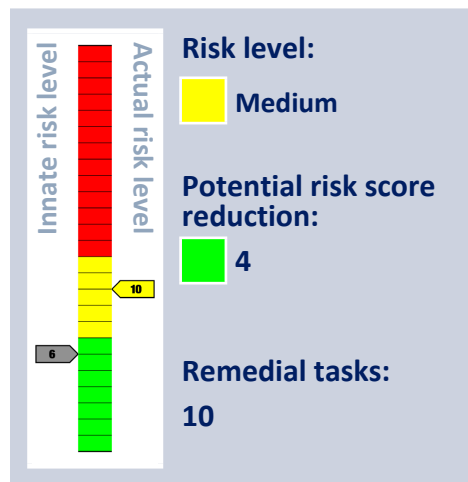
# Multiplay - Junior

1. Timber is decayed.
2. Surface is wearing.
3. Timber is decayed.
4. Bolt(s) loose.
5. Fixtures loose or missing.
6. Item is not secure.

Timber is decayed.

Surface is wearing.

Some beams decaying. Replace/reinforce.  
Monitor for further significant decay.

Bolt(s) loose.

Fixtures loose or missing.

Climbing wall is not secured to surface. Monitor and consider alterations if becomes loose.

Replace affected parts.

Monitor for significant deterioration and rectify when necessary.

Check on a routine basis., Repair.

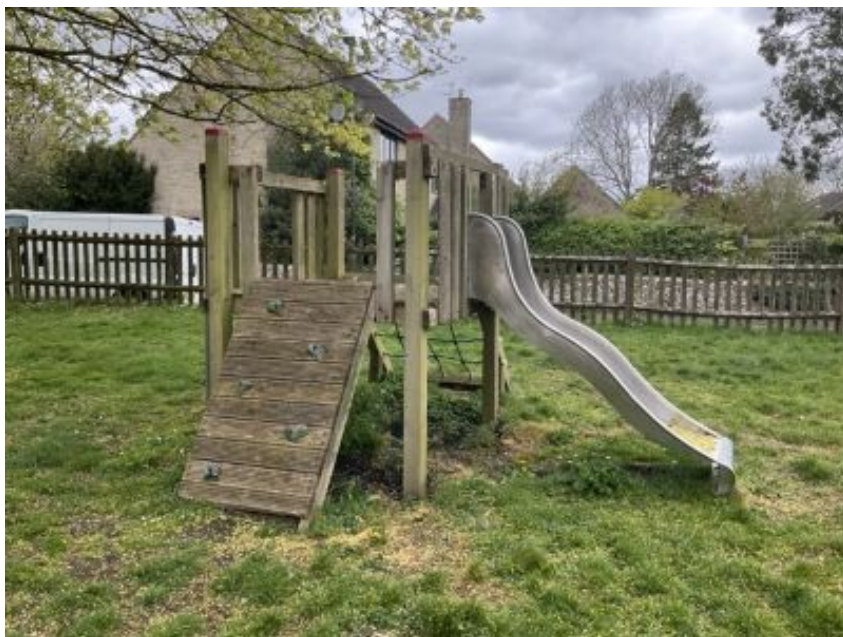
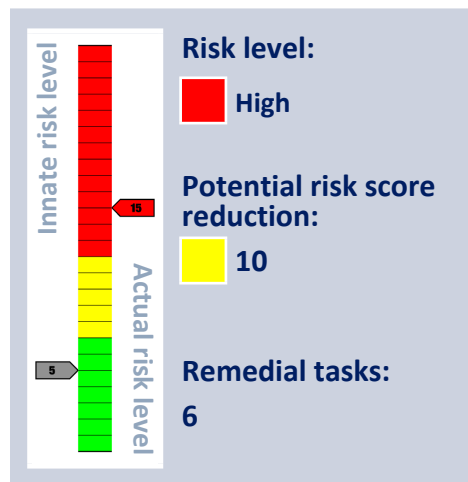
# Multiplay - Small

1. Timber is decayed.
2. Timber is decayed.
3. Timber is decayed.

Timber is decayed.

White fungus growth on underside of platform. Clean off and treat timber.  
Monitor for significant decay.

Replace affected parts.

Check on a routine basis., Repair.

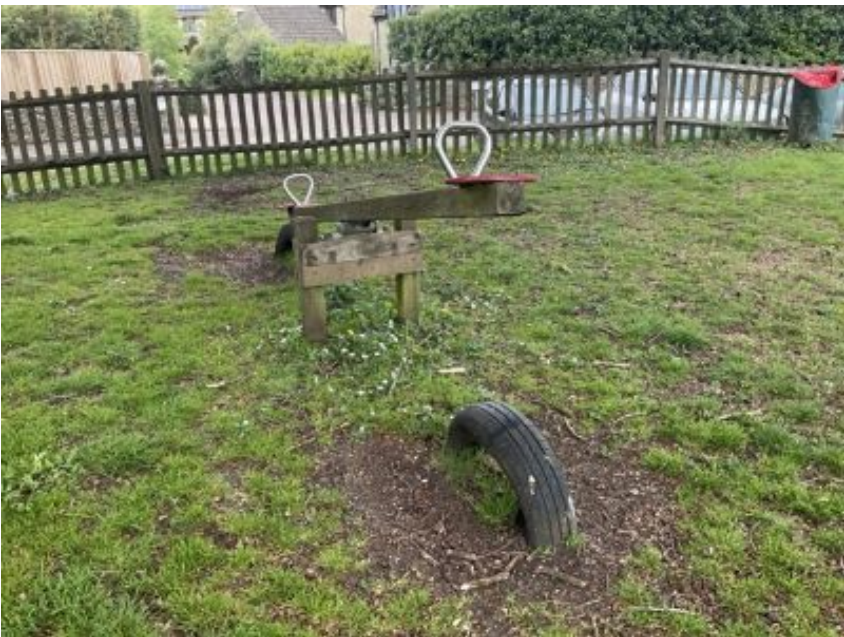
# Rocker - Seesaw

There is evident wear to the internal mechanism, resulting in excessive sideways movement.

Bolts are loose.

Loose in ground.

Timber is decayed.

Minor decay on top of support post.  
Cut down to good wood, chamfer edges and treat timber.  
Monitor timber softening at ground level.

Repair.

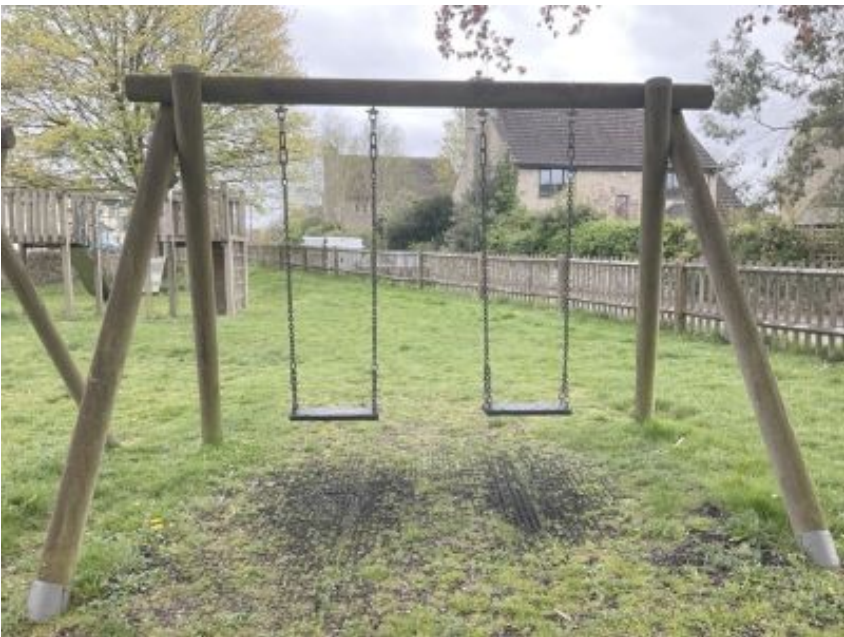
# Swing - Junior - 1 Bay 2 Seat

Surface needs repair.

Repair.

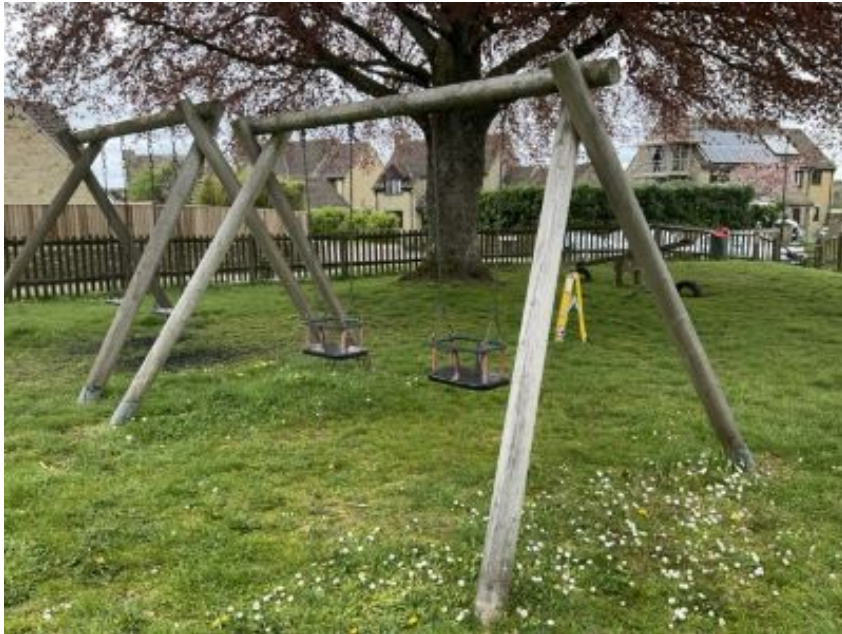
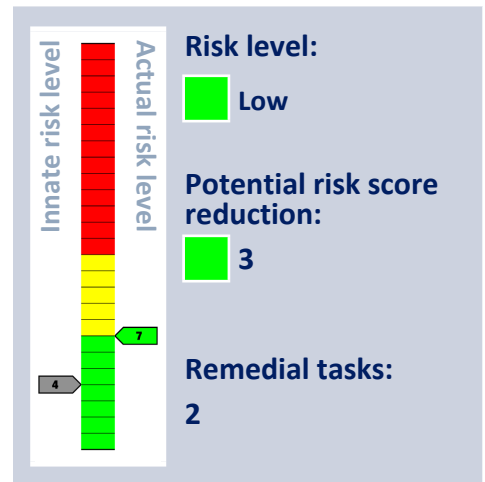
## Swing - Toddler - 1 Bay 2 Seat

Some chain wear.

Cap missing.

Monitor for further deterioration and replace before 40% wear.

Replace.
